## CMS MOTORHOME INSPECTION FORM

| Make & Model | Autocruise Wentworth |
| Reg Number - NO GAP | YN07GDE |

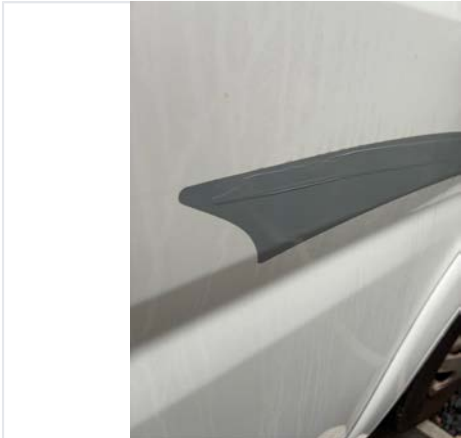
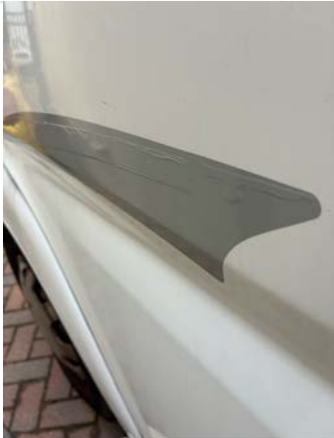
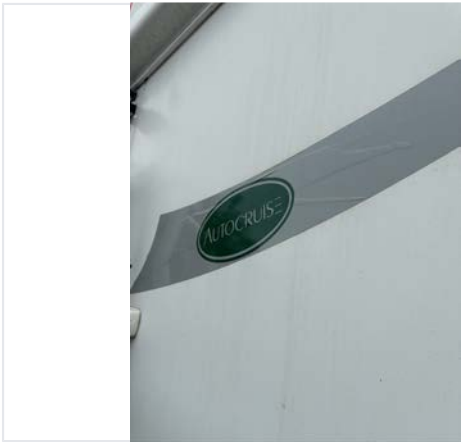
| Decals | Need attention |
| Decals Further Info | Faded and Some replaced over the old ones |

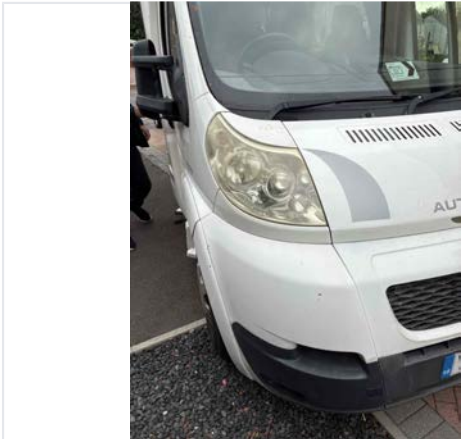
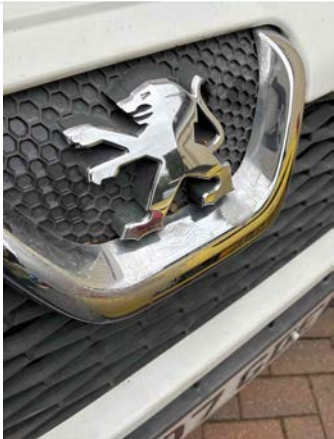
| Damage Further Info | Faded headlights // Delaminated badge // Faded paintwork on front bumper // Scuff on n/s front bumper // Scuff to wheel arch o/s/f // Paint fallout on a pillar // Rust on o/s/r corner // Scratch on o/s/r pillar // Tow bar rusty // Outside habitation lock damage // Scratches down the n/s |

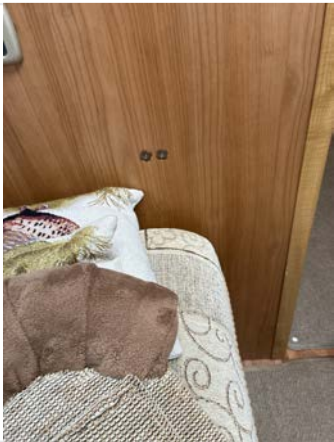
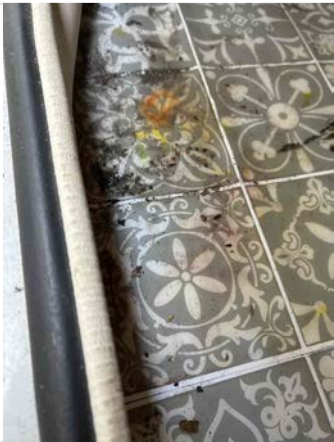
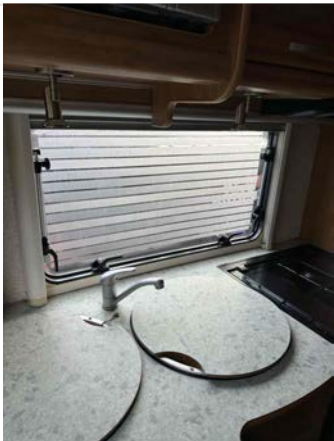
| Damage Info | Under n/s bench seats showing high floor added tiles // Not original glass |

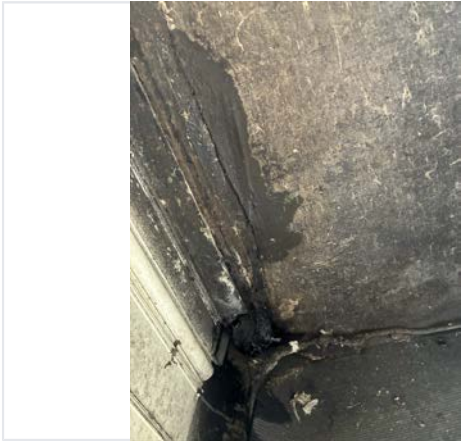
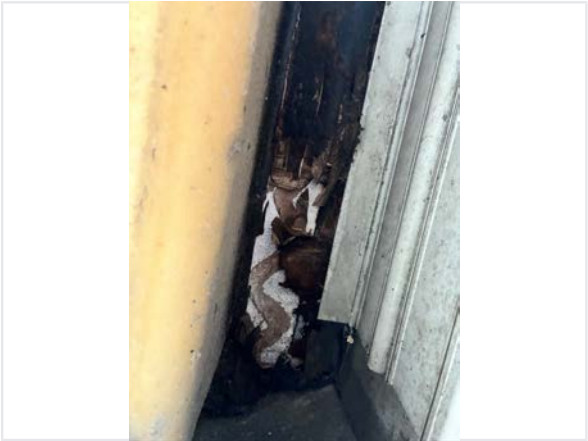
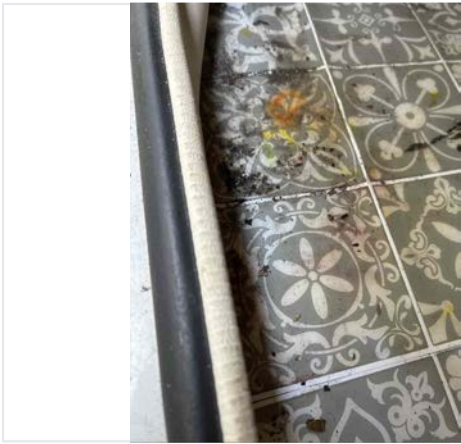
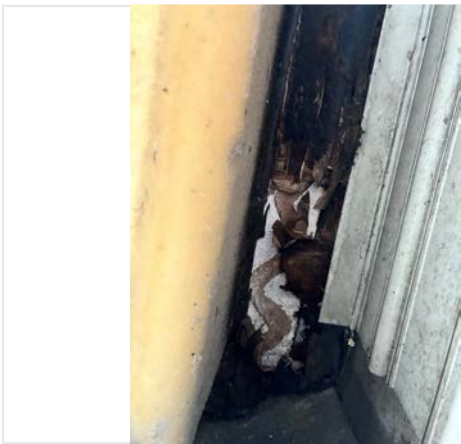
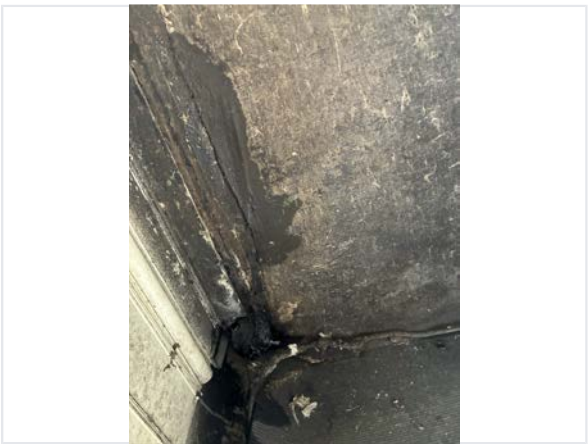
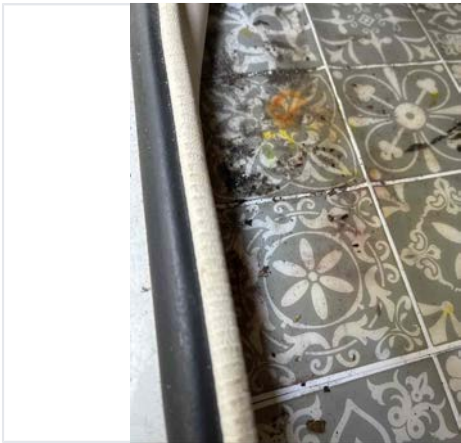
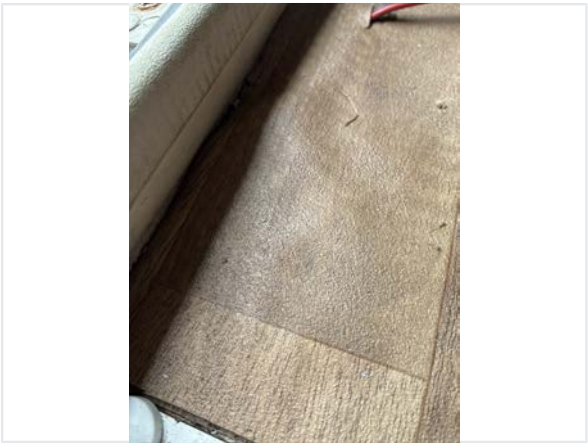
| Damp Info | Dry rot under floor under cooker |
| Floor Info | Dry rot under floor in rear and down the sides |

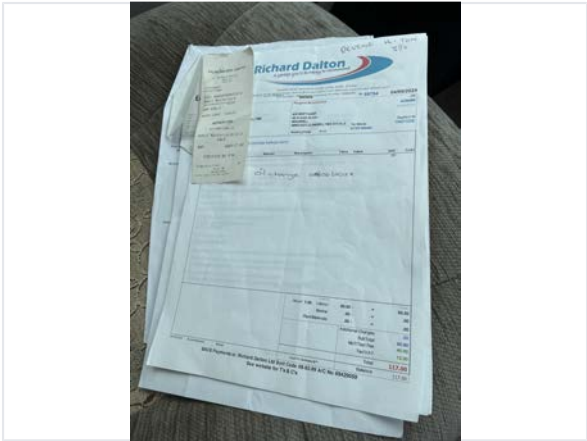
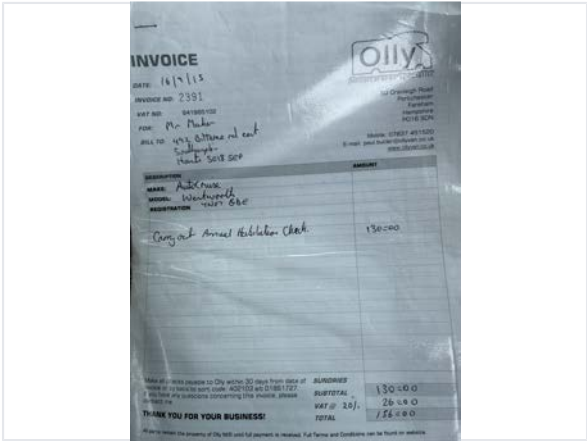
| Service Info | 2 services last one photographed |
| Habitation Info | One report photographed |
