CMS MOTORHOME INSPECTION FORM

Make & Model	Rapido Series 6 690
Reg Number - NO GAP	DX11GYA
HPI Clear	Yes
VAT	No
Engine Size	2.3l
BHP	130 bhp
Transmission	Manual
Vehicle Weight (kg)	3500kg
Miles or KM	Miles
Mileage	48370
Confirm miles (within 5,000)	Yes
Is Mileage Warranted	Yes
Engine Keys Count	2
V5 present	Yes
V5 VIN Match	Yes
MOT Expiry Date	01/07/2027
Vehicle Registration Date	11/95/2011

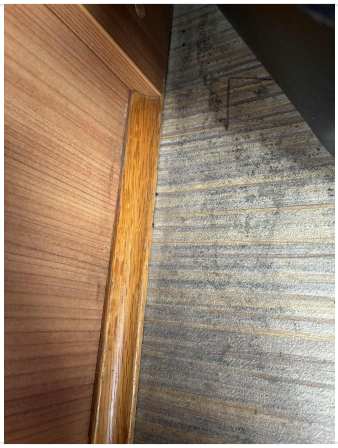
Damp (visible/soft)	Yes
Damp Info	Staining and Pimpling on toilet / shower roof Wall Stained and rippled under off side bench seat Rear wall in garage 100 readings
Floor damp/spongy/damaged	Yes
Floor Info	Floor soft in garage and stained 100 readings all Over
