CMS MOTORHOME INSPECTION FORM

Make & Model	Rapido Le Randonneur 785F
Reg Number - NO GAP	FH03AWW
HPI Clear	Yes
VAT	No
Engine Size	2.8
BHP	123
Transmission	Manual
Vehicle Weight (kg)	3500
Miles or KM	Miles
Mileage	56689
Confirm miles (within 5,000)	Yes
Is Mileage Warranted	Yes
Engine Keys Count	2
V5 present	Yes
V5 VIN Match	Yes
MOT Expiry Date	08/03/2027
Vehicle Registration Date	03/07/2003

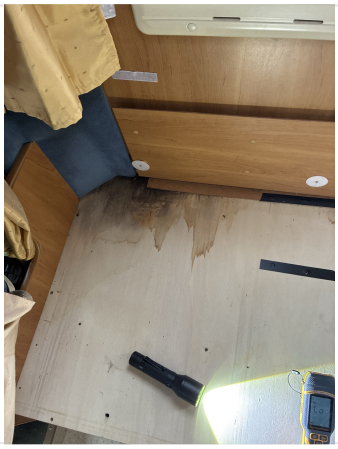
Damp (visible/soft)	Yes
Damp Info	Behind drivers seat visible
Floor damp/spongy/damaged	No
