CMS MOTORHOME INSPECTION FORM

Make & Model	Elddis Encore 250
Reg Number - NO GAP	FJ21BVM
HPI Clear	Yes
VAT	No
Engine Size	2.3
BHP	140
Transmission	Automatic
Vehicle Weight (kg)	3500
Miles or KM	Miles
Mileage	6328
Confirm miles (within 5,000)	Yes
Is Mileage Warranted	Yes
Engine Keys Count	2
V5 present	Yes
V5 VIN Match	Yes
MOT Expiry Date	18/06/2027
Vehicle Registration Date	28/04/2021

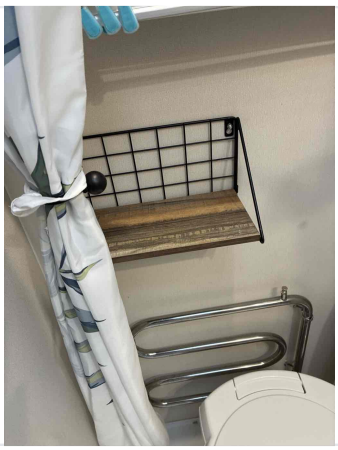
Internal Extras	tracker, Carpets, Cab blinds, cab A/C, Bluetooth, Cruise control, DAB radio, Heated mirrors, Multifunction steering wheel, Oven, Other (inc accessories)
Other Extras	Microwave
Electrics turn on	Yes
Control panel damaged	No
Stereo turn on	Yes
Smell or signs of smoking	No
Cushions correct	Yes
Boiler present	Yes
Overhead lockers ready	Yes
Internal Damage	Yes
Damage Info	Shelves added in lounge area Mattress slightly fraud along the join Fridge door missing plastic insert so comes away when you open it.

Damp Info	High reading under bench
Floor damp/spongy/damaged	No
