CMS MOTORHOME INSPECTION FORM

Make & Model	Bus stop VW Conversions
Reg Number - NO GAP	GL04OWE,GD67XYN
HPI Clear	Yes
VAT	No
Engine Size	2.0L
BHP	130bhp
Transmission	Manual
Vehicle Weight (kg)	3000kg
Miles or KM	Miles
Mileage	50406
Confirm miles (within 5,000)	Yes
Is Mileage Warranted	Yes
Engine Keys Count	2
V5 present	Yes
V5 VIN Match	Yes
MOT Expiry Date	
Vehicle Registration Date

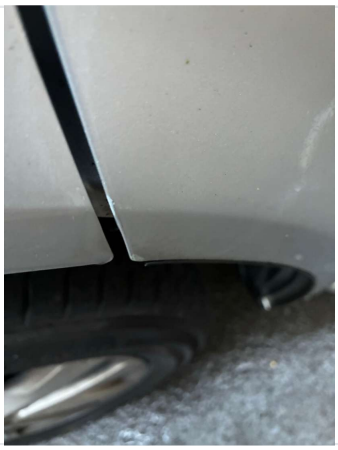
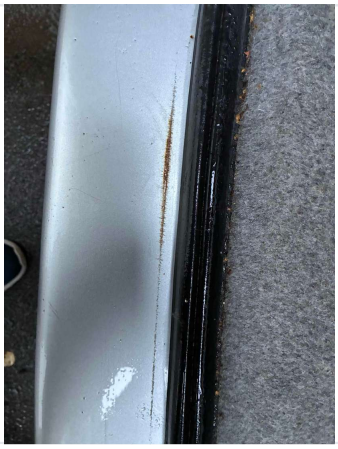
External Extras	Alloys, Front fog lights, Reversing camera, Solar panel, Roof rack
Other External Extras	N/A
Decals	N/A
Any Damage Found	Yes
Damage Further Info	Paint peel on passenger door edge just starting to rust Small dink on rear door Small dink on passenger door as described by customer Rust near near side wheel Arch Front bumper been repaired slightly different colour and some crazing Rust starting to show on off side rear wheel arch Scratch on rear bumper (top)

Windscreen	No damage
Alloy Wheels	Good
Tyres illegal/cracking/out of date	No
Electric Step	N/A
Self levelling work	N/A
Pop top canvas damage	Yes
Pop Top Damage Info	Small holes os rear pop top //

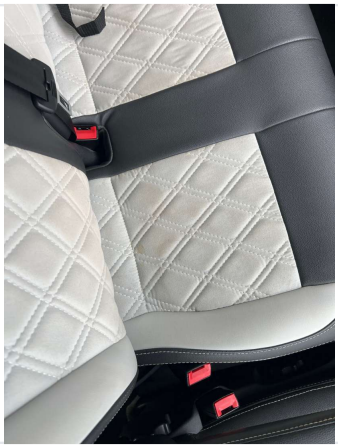
Internal Extras	Bluetooth, cab A/C, DAB radio, Cruise control, Multifunction steering wheel, Part leather
Other Extras	N/A
Electrics turn on	Yes
Control panel damaged	No
Stereo turn on	Yes
Smell or signs of smoking	No
Cushions correct	Yes
Boiler present	N/A
Overhead lockers ready	Yes
Internal Damage	Yes
Damage Info	Slighty stained upholstery //
