CMS MOTORHOME INSPECTION FORM

Make & Model	Ace Napoli
Reg Number - NO GAP	GR57XAG
HPI Clear	Yes
VAT	No
Engine Size	2.2
BHP	100
Transmission	Manual
Vehicle Weight (kg)	3500
Miles or KM	Miles
Mileage	31432
Confirm miles (within 5,000)	Yes
Is Mileage Warranted	Yes
Engine Keys Count	2
V5 present	Yes
V5 VIN Match	Yes
MOT Expiry Date	24/09/27
Vehicle Registration Date	1/09/07

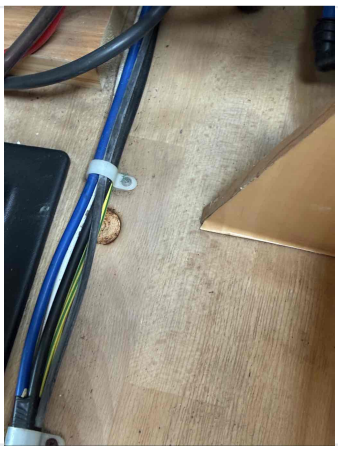
Damp (visible/soft)	Yes
Damp Info	Soft floor rear/ delaminated / peeling walls and evidence of staining on rear wall /bath-room wall stain and soft / nsr window lower peeling and soft and stain
Floor damp/spongy/damaged	Yes
Floor Info	Floor springy on both sides of van
