CMS MOTORHOME INSPECTION FORM

Make & Model	Swift Bessacarr E540
Reg Number - NO GAP	HX07HMA
HPI Clear	Yes
VAT	No
Engine Size	2.2
BHP	130
Transmission	Manual
Vehicle Weight (kg)	3500
Miles or KM	Miles
Mileage	34012
Confirm miles (within 5,000)	Yes
Is Mileage Warranted	Yes
Engine Keys Count	1
V5 present	Yes
V5 VIN Match	Yes
MOT Expiry Date	15/05/27
Vehicle Registration Date	03/05/07

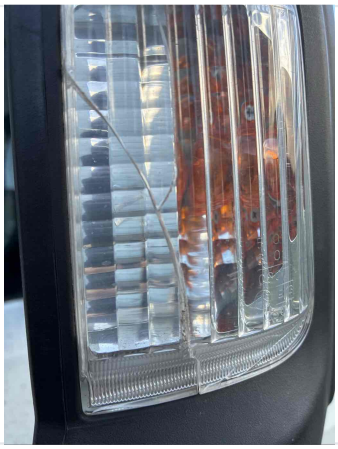
External Extras	Awning, Gaslow, Reversing camera, Tv Aerial, Bike Rack, Solar panel
Other External Extras	N/A
Decals	Good
Any Damage Found	Yes
Damage Further Info	Peeling paint to bonnet // Scratch to front valance // Crack o/s indicator lense // Peeling paint drivers door // Broken piece off gas locker door // Scuffs to o/s valance // Cracks to r/o/s corner valance // Scuffs to n/s // N/s/r wheel arch broken // Headlamps discoloured //

Windscreen	No damage
Alloy Wheels	N/A
Tyres illegal/cracking/out of date	Yes
Tyre Further Info	R/n/s old and perished and cracked

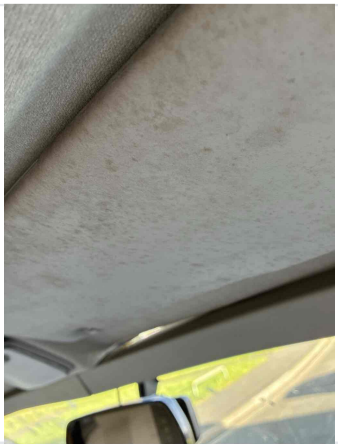
Internal Extras	Alarm, Bluetooth, Cab blinds, Cruise control, Oven, Tv(s)
Other Extras	2000w inverter
Electrics turn on	Yes
Control panel damaged	No
Stereo turn on	Yes
Smell or signs of smoking	No
Cushions correct	Yes
Boiler present	Yes
Overhead lockers ready	No
Internal Damage	Yes
Damage Info	Overcab skylight cracked at several points// Flip down cab tv missing // All cab surfaces with damp/mould discolouration // Scratch to kitchen cabinet // Bench cushions mouldy //

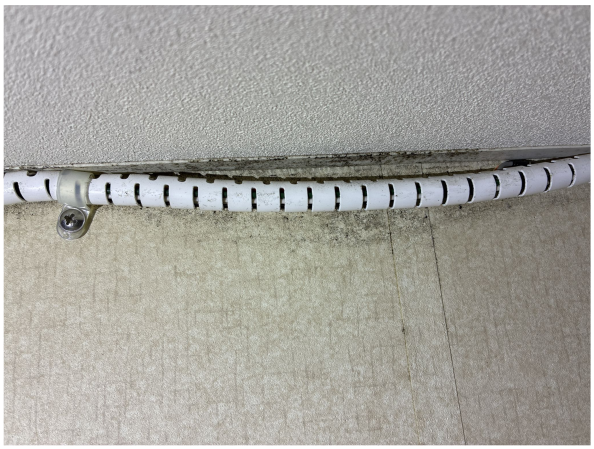
Damp (visible/soft)	Yes
Damp Info	O/s cupboard above bench mould // Rippled paper beneath o/s hab window // Mould under o/s bench seat // Rippled wall beneath n/s hab window // Wet very soft wall beneath n/s bench & locker door // Around hab door rippled // Rear wall below bathroom window rippled and soft //
Floor damp/spongy/damaged	No
