CMS MOTORHOME INSPECTION FORM

Make & Model	Auto - Trail Cheyenne 630 SE
Reg Number - NO GAP	KN03LOH
HPI Clear	Yes
VAT	No
Engine Size	2.7
BHP	155
Transmission	Automatic
Vehicle Weight (kg)	3800
Miles or KM	Miles
Mileage	51644
Confirm miles (within 5,000)	Yes
Is Mileage Warranted	Yes
Engine Keys Count	2
V5 present	Yes
V5 VIN Match	Yes
MOT Expiry Date	25/06/2027
Vehicle Registration Date	29/05/2003

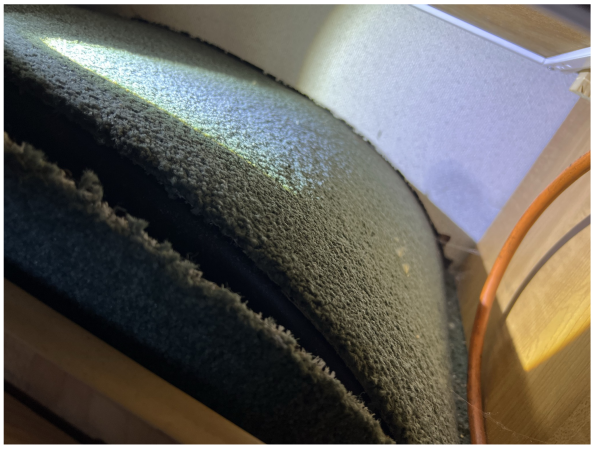
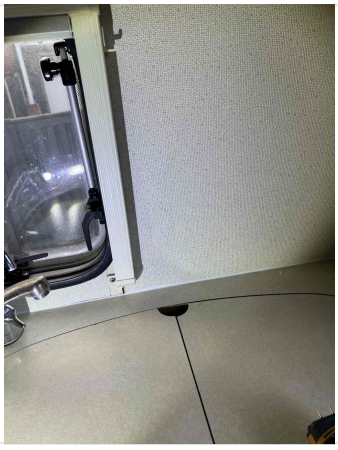
Damp (visible/soft)	Yes
Damp Info	Blue under ns front window // blue under nsr wheel arch // blue in rear panel all reading highs
Floor damp/spongy/damaged	No

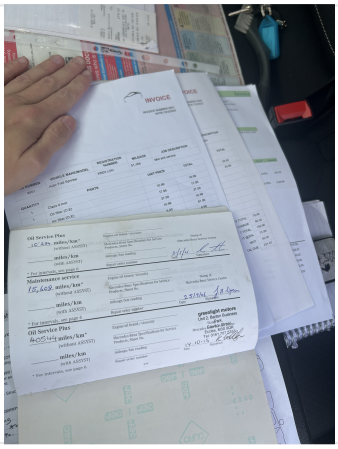
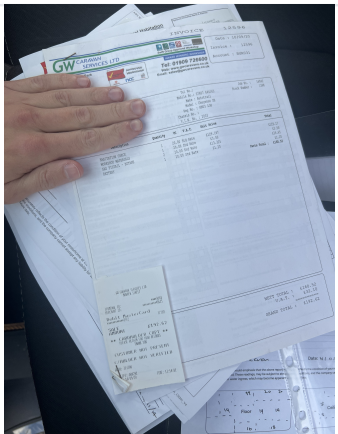
Engine Service History	Partial
Service Info	3 stamps 3 invoices
Date of Last Engine Service	14/10/2015
Cam belt changed	N/A
Habitation service reports	Partial
Habitation Info	2 invoices
Date of Last Habitation Service	10/09/2020
