CMS MOTORHOME INSPECTION FORM

Make & Model	Auto-sleepers Duetto
Reg Number - NO GAP	RRR239R
HPI Clear	Yes
VAT	No
Engine Size	2.4L
BHP	100 bhp
Transmission	Automatic
Vehicle Weight (kg)	3280
Miles or KM	Miles
Mileage	38224
Confirm miles (within 5,000)	Yes
Is Mileage Warranted	Yes
Engine Keys Count	2
V5 present	Yes
V5 VIN Match	Yes
MOT Expiry Date	01/12/2026
Vehicle Registration Date	22/04-2004

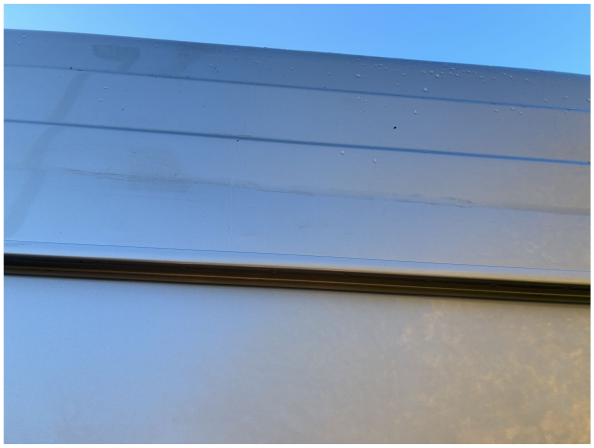
External Extras	Awning, Bike Rack, Manual step, Solar panel
Other External Extras	N/A
Decals	Good
Any Damage Found	Yes
Damage Further Info	Rust spots above passenger door Chip on passenger door Nearside window rubber perished Scratch above hab window near side Scratch /dent along top panel rear off side

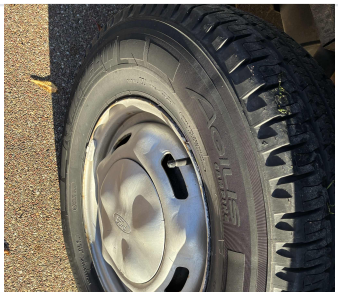
Windscreen	No damage
Alloy Wheels	N/A
Tyres illegal/cracking/out of date	Yes
Tyre Further Info	Tyres 2017 but in reasonable condition

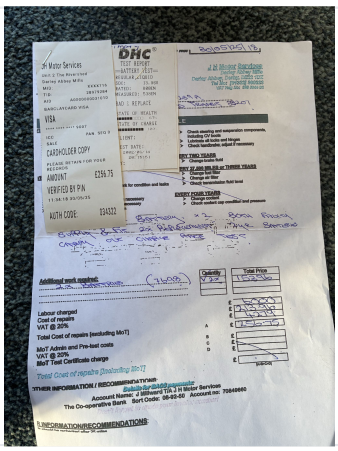
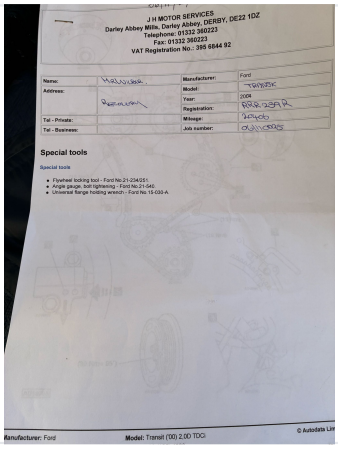
Manuals present	Yes
Engine Service History	Full
Service Info	All Invoices present all 20 years Latest pictured
Date of Last Engine Service	30/05/2025
Cam belt changed	Yes
Cam belt info	Changed 2009
Habitation service reports	None
