# CMS MOTORHOME INSPECTION FORM

| Make & Model | Leisuredrive Celebration |
| Reg Number - NO GAP | SG10ADS |

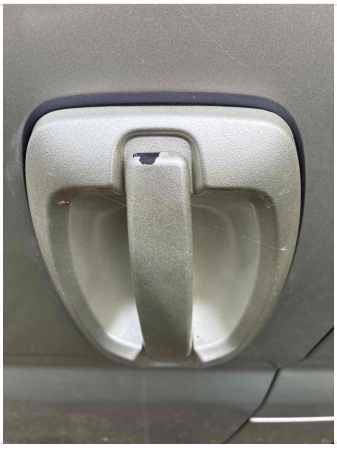
| Any Damage Found | Yes |
| Damage Further Info | Paint peel n/s above side door<br>Scratch above n/s/r wheel arch<br>Paint peel on n/s hab door handle |

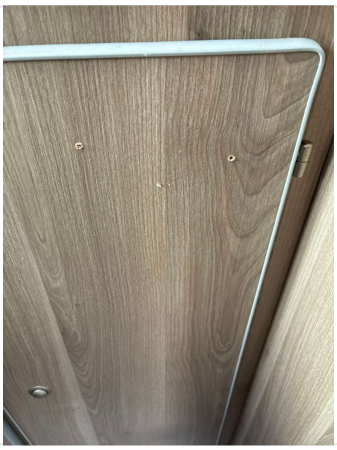
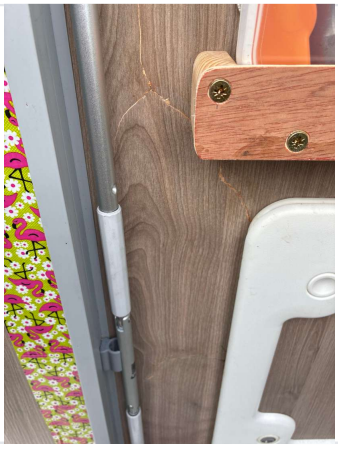
| Internal Damage | Yes |
| Damage Info | Discolouration of plastic trim o/s door pillar rear edge<br>Screw holes lower cupboard door<br>Rear panel cracked (view from rear doors ) |
