CMS MOTORHOME INSPECTION FORM

Make & Model	Swift Voyager 494
Reg Number - NO GAP	SP24YEX
HPI Clear	Yes
VAT	No
Engine Size	2.0L
BHP	130 bhp
Transmission	Manual
Vehicle Weight (kg)	3000kg
Miles or KM	Miles
Mileage	9313
Confirm miles (within 5,000)	Yes
Is Mileage Warranted	Yes
Engine Keys Count	2
V5 present	Yes
V5 VIN Match	Yes
MOT Expiry Date	01/03/2027
Vehicle Registration Date	19/03-2024

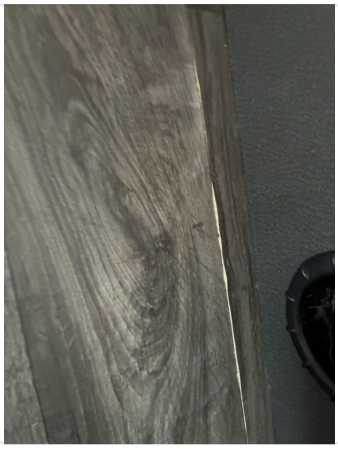
Damp (visible/soft)	No
Floor damp/spongy/damaged	Yes
Floor Info	Floor soft and delaminating Behind drivers seat tight to wall
