CMS MOTORHOME INSPECTION FORM

Make & Model	Elddis 175 Magnum GT
Reg Number - NO GAP	WA66GNJ
HPI Clear	Yes
VAT	No
Engine Size	2.0L
BHP	120 bhp
Transmission	Manual
Vehicle Weight (kg)	3500kg
Miles or KM	Miles
Mileage	17603
Confirm miles (within 5,000)	Yes
Is Mileage Warranted	Yes
Engine Keys Count	2
V5 present	Yes
V5 VIN Match	Yes
MOT Expiry Date	20/07/2027
Vehicle Registration Date	01/11/2016

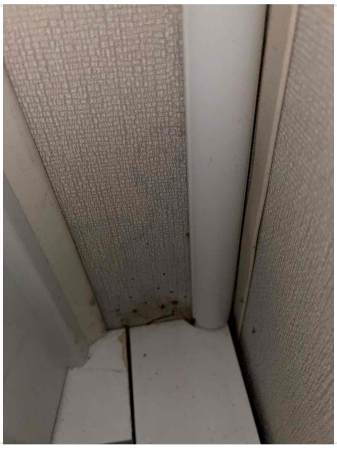
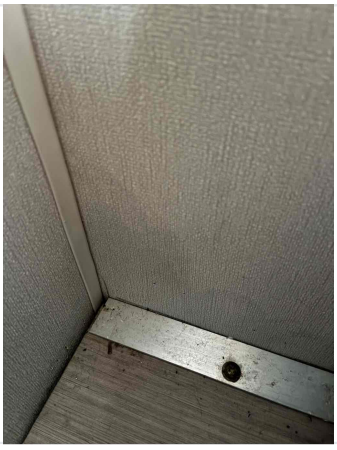
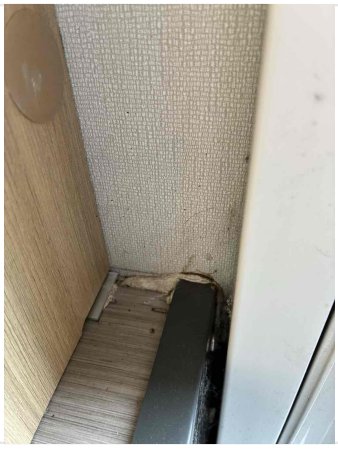
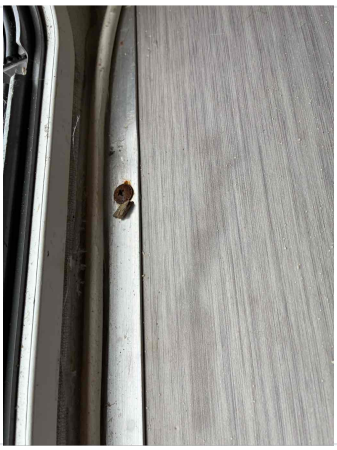
Damp (visible/soft)	Yes
Damp Info	Rear wall in rear cupboard blue staining and 99 readings
Floor damp/spongy/damaged	Yes
Floor Info	Floor stained and starting to soften under near side bench seat Floor rippled and 99 readings under off side bench seat Floor in bathroom reading 99 and rippled Also floor in washroom cupboard rippled and reading 99

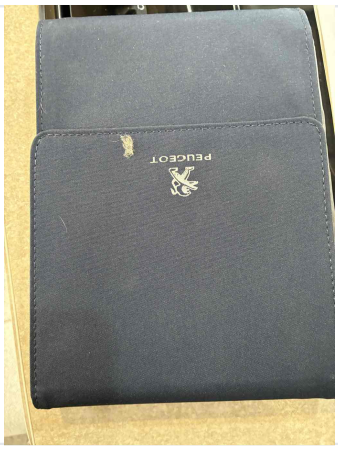
Manuals present	Yes
