## CMS MOTORHOME INSPECTION FORM

| Make & Model | Elddis Riva Gold 155 |
| Reg Number - NO GAP | CV16NBE |

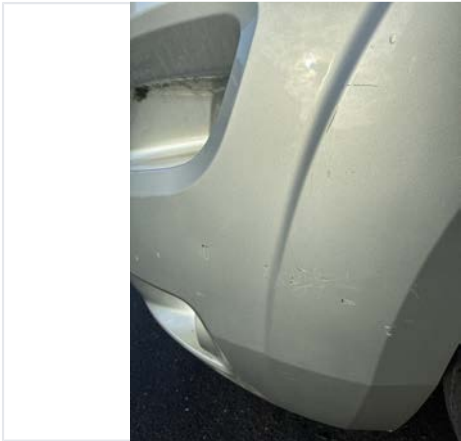
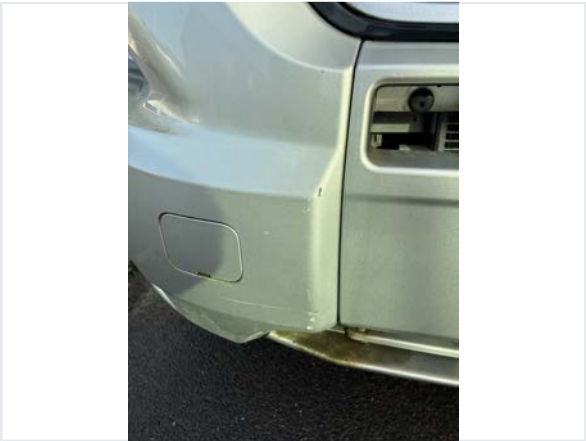
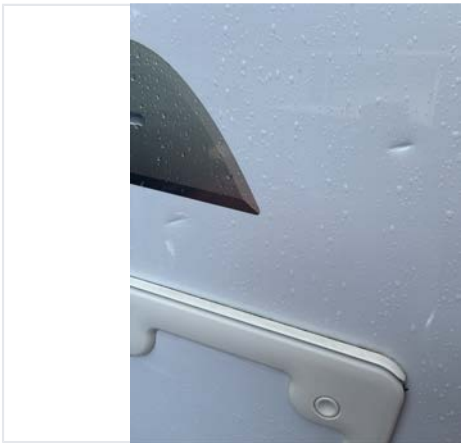
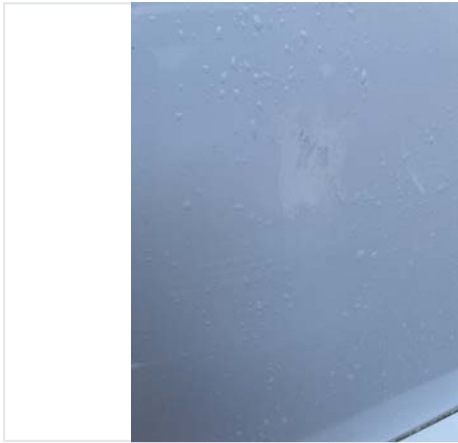
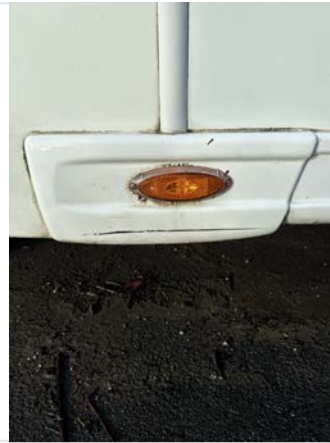
| Any Damage Found | Yes |
| Damage Further Info | Scratches to f/n/s corner valance<br>Scratch front valance left of reg plate<br>Two dents to rear wall<br>Overpainting to 4 marks on rear wall<br>Scuff to lower valance n/s (right of passenger door) |

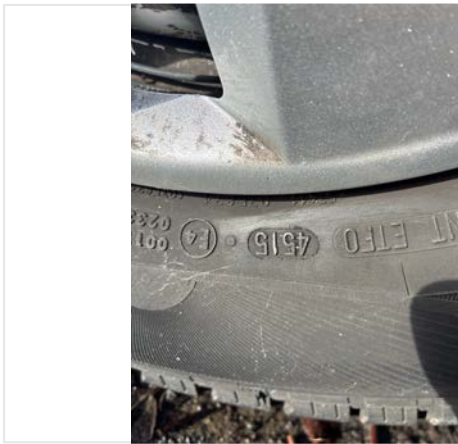
| Tyres illegal/cracking/out of date | Yes |
| Tyre Further Info | All tyres in good order but 2015 |

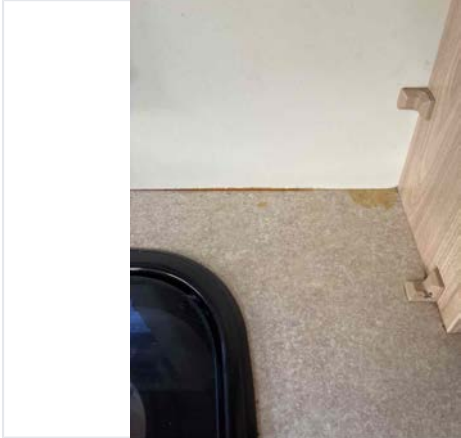
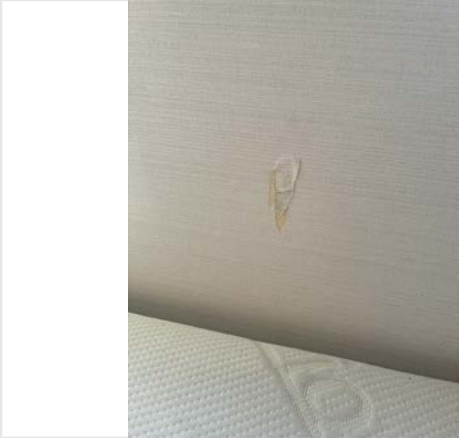
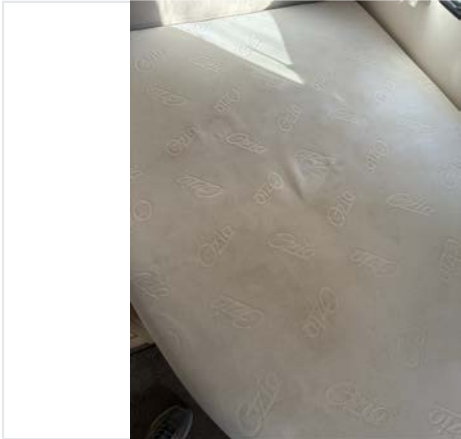
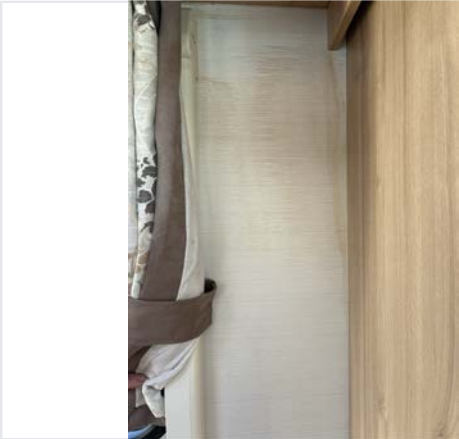
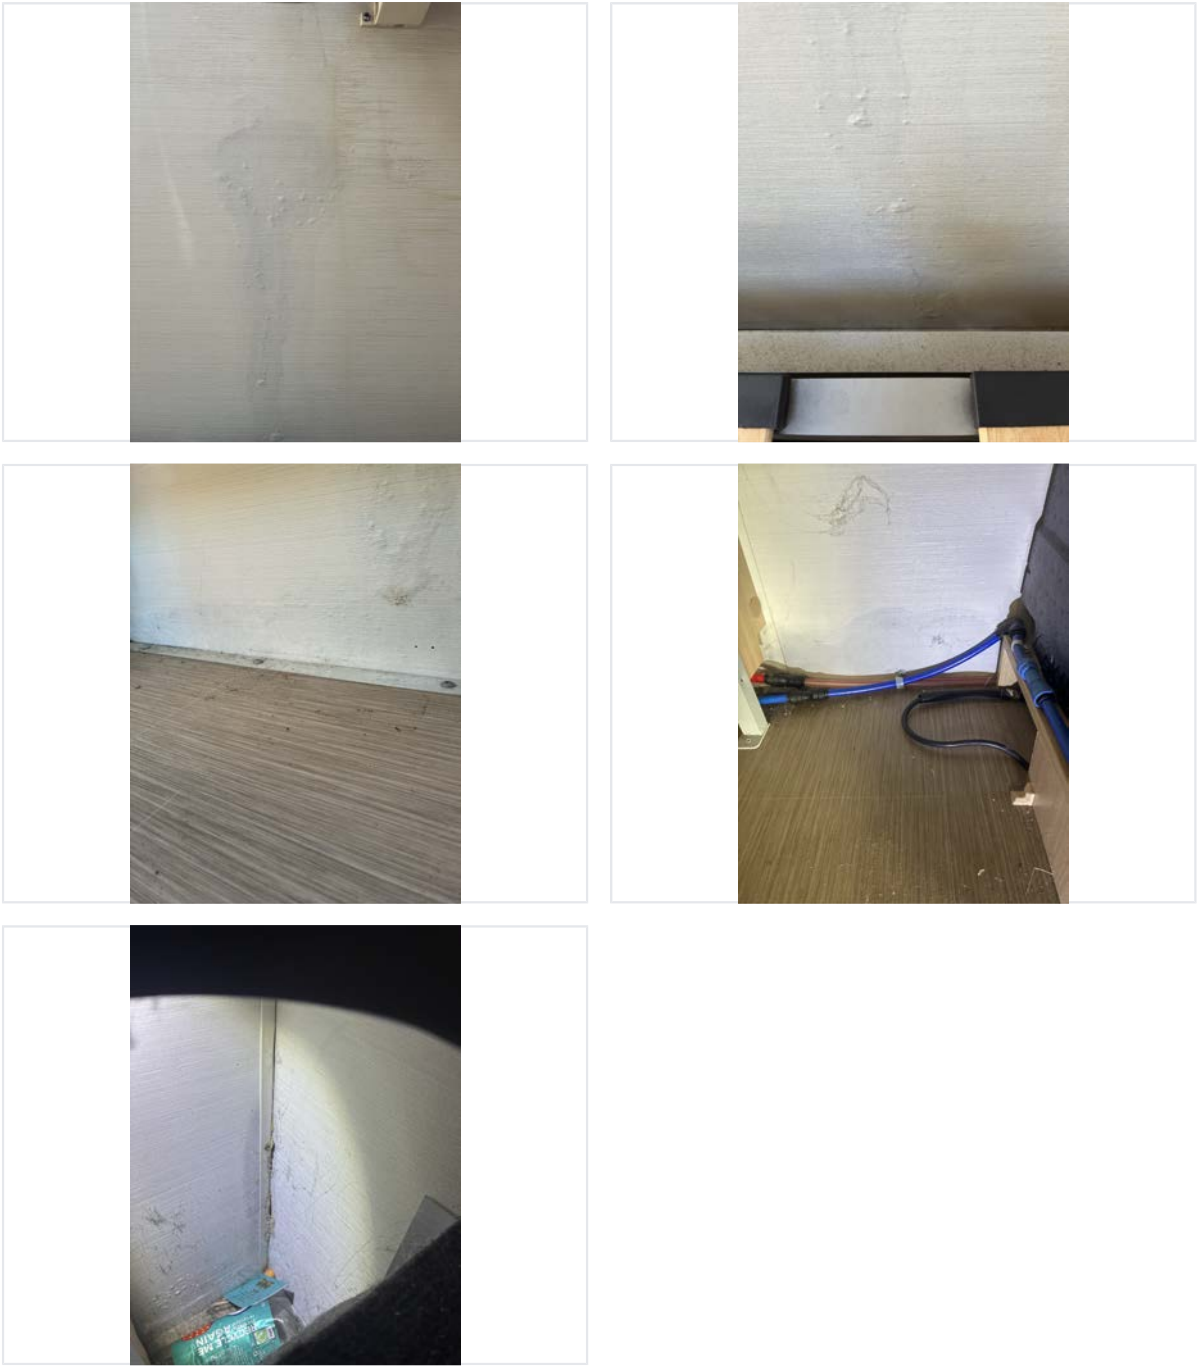
| Internal Damage | Yes |
| Damage Info | Glue staining on kitchen area work surface<br>N/s wall in bedroom area damaged<br>Mattress staining |

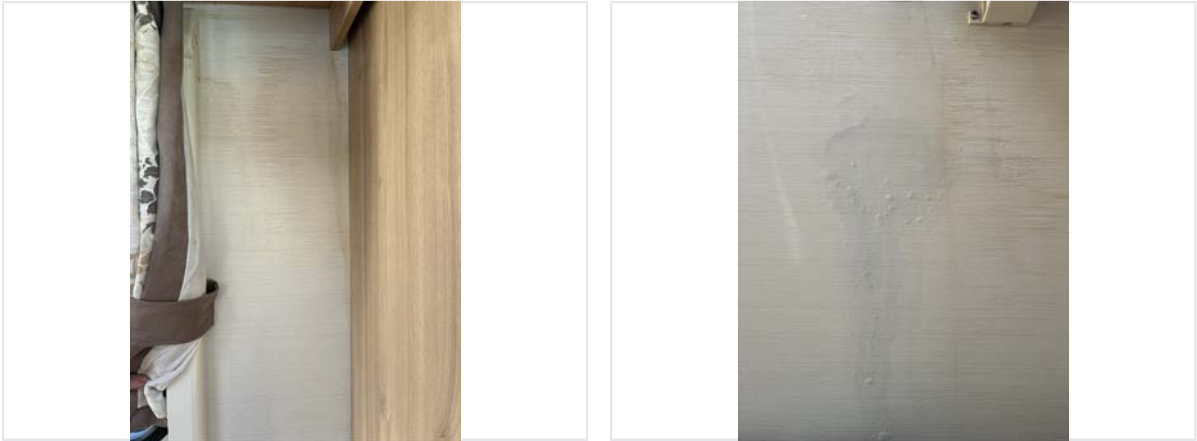
| Damp (visible/soft) | Yes |
| Damp Info | Damp / blue & pimpleing under n/s hab window to floor (bench area)<br>Centre Rear wall and n/s rear corner blue and |
